Product Safety Recall

Kubota BX Tractors, GR Ride-On Mowers and ZD & ZG Zero Turn Mowers

Supplied 14 January 2014 to 23 August 2018

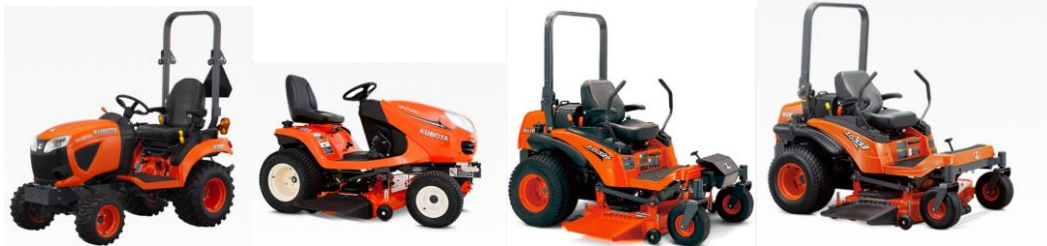
Defect: The coolant reserve tank cap may be clogged by plastic produced during the injection moulding process.

Hazard: Under some conditions such as overheating, pressure inside the radiator can build up which may cause the coolant reserve tank cap to come off and high temperature coolant to spray out. This hot liquid could injure the rider or bystanders.

What to do: Replacement coolant reserve tank caps will be sent directly to consumers (free of charge) as parts become available, along with instructions for installation. If customers cannot wait until the replacement coolant reserve tank cap is mailed to them, they can take their existing coolant reserve tank cap to their Kubota dealer to inspect and repair (if necessary). The dealer can drill out the breather hole if needed.
