**Bulletin Number** : SFI-A-15-024  
**Date of Issue** : July 2015  
**Replacement SB No.** : N/A  
**KTA Reference No.** : AG15-15  
**Author** : C. Chapman

<b>SUBJECT:</b>	BX24/25 Seat nut torque check
<b>MODEL:</b>	BX24, BX25, BX25D & BX25D-1
<b>SERIAL No. AFFECTED:</b>	BX24: 50001 – 64781 BX25: 50001 – 67205 BX25D: 10001 – 17269 BX25D-1: 20001 – 23263

**MANDATORY CAMPAIGN LEVEL 1 "Recall - Action Immediately"**

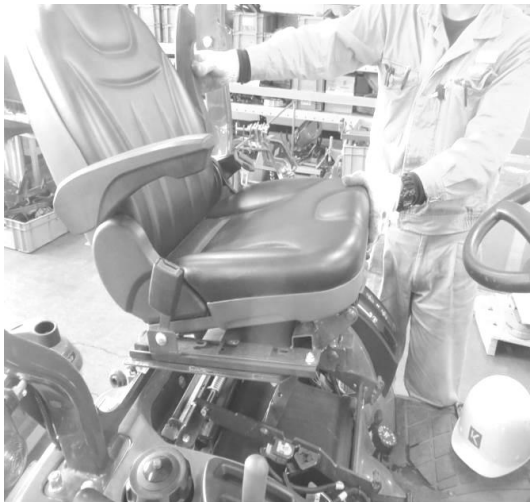
*Figure 1*

With the seat in the lowered, operation position (*Figure 1*), safely apply a lateral side-to-side force to the seat, making note for excessive movement.

NOTE: The seat is designed to rotate, but excessive side-to-side or fore-aft movement should not occur.

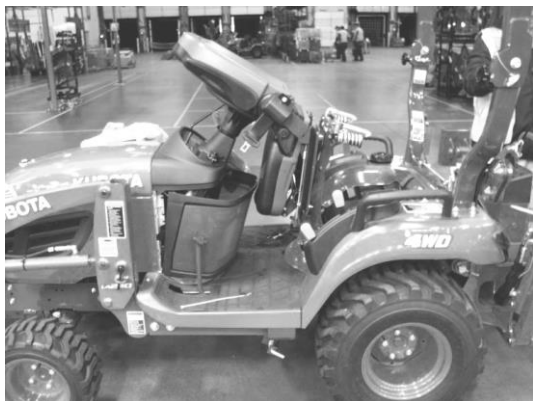
*Figure 2*

Safely lift the Seat to locate the Jam Nut (*Figure 2*).

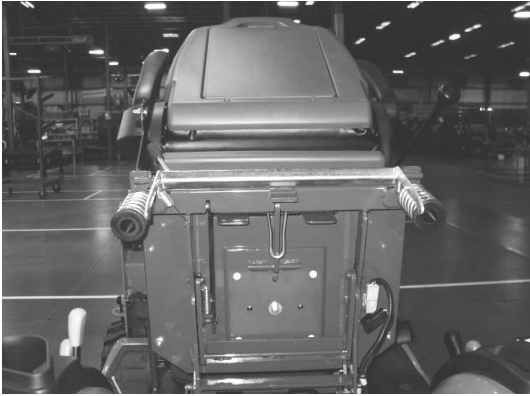
*Figure 3*

Once the Seat has been lifted, locate the Jam Nut on the bottom portion of the Seat (*Figure 3 & 4*).

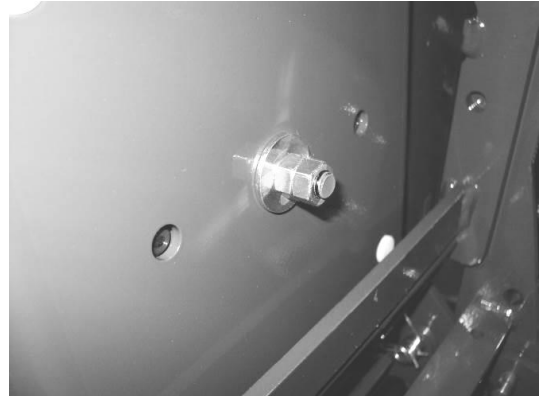
*Figure 4*

Visually confirm the following three items (*Figure 4*):

- Two nuts are installed (Top Nut and Bottom Jam Nut)
- The Bottom Jam Nut is secure against the Top Nut
- The Top Nut is secure against the Washer

**Warning: IF YOUR PRODUCT EXPERIENCES A LOOSE SEAT, AND/OR THE LISTED THREE ITEMS CAN NOT BE CONFIRMED, do not operate the machine UNTIL repaired. Please CONTACT your authorised selling Kubota DEALER TO SCHEDULE AN APPOINTMENT FOR REPAIR.**
